Wicklow Mountains Path Survey

Brockagh	
Start to Finish:	T 133 ₅₀ 973 ₇₀ to O 097 ₆₈ 005 ₃₅
Altitude (lowest – highest):	280m – 557m
Weather:	Sunny, fresh breeze, after rainy June.
Access:	Laneway beside McCoy's shop, Laragh
Surveyed by:	John Monaghan, 24 / 6 / 02

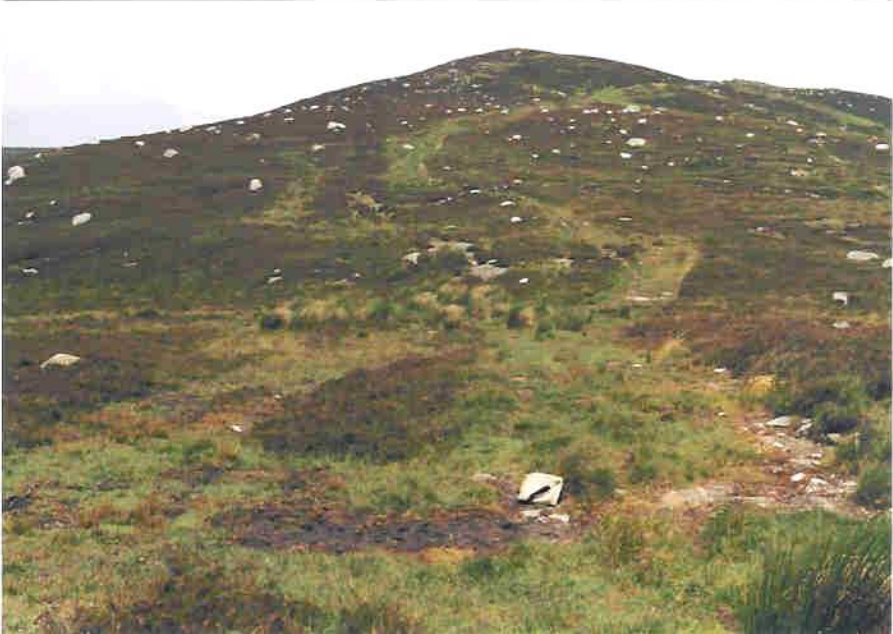
<p><u>pic16</u> looking up slope ahead, wet area in foreground</p>
4	70m on	wet area, braiding, some loose stones about
5	125 ₅₈ 979 ₂₇	end of braiding from No.3

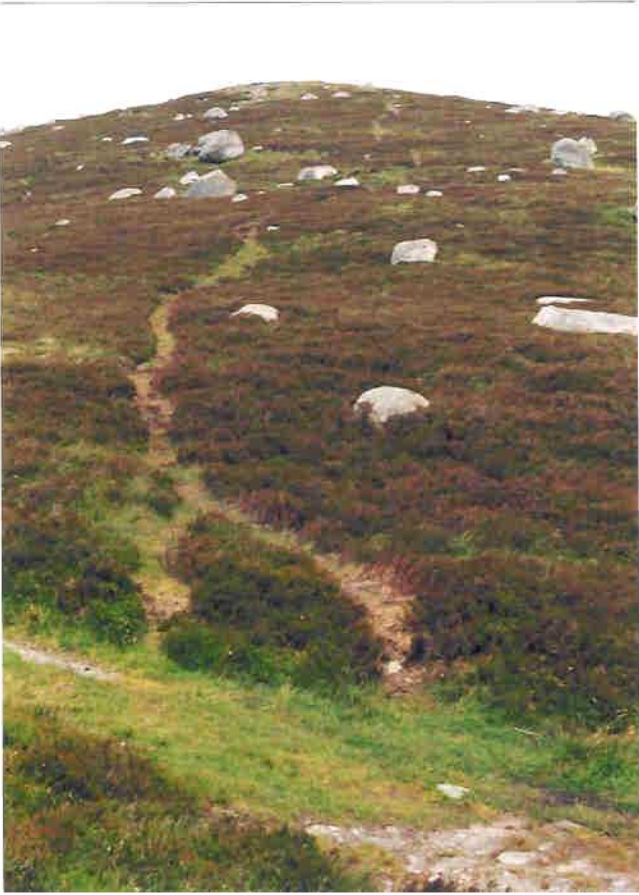
6	124 ₉₆ 982 ₉₇	<p>pic17 shows minor path, in good condition, from here up to Pt.470m; main path going right to left at bottom of pic</p> <hr/>

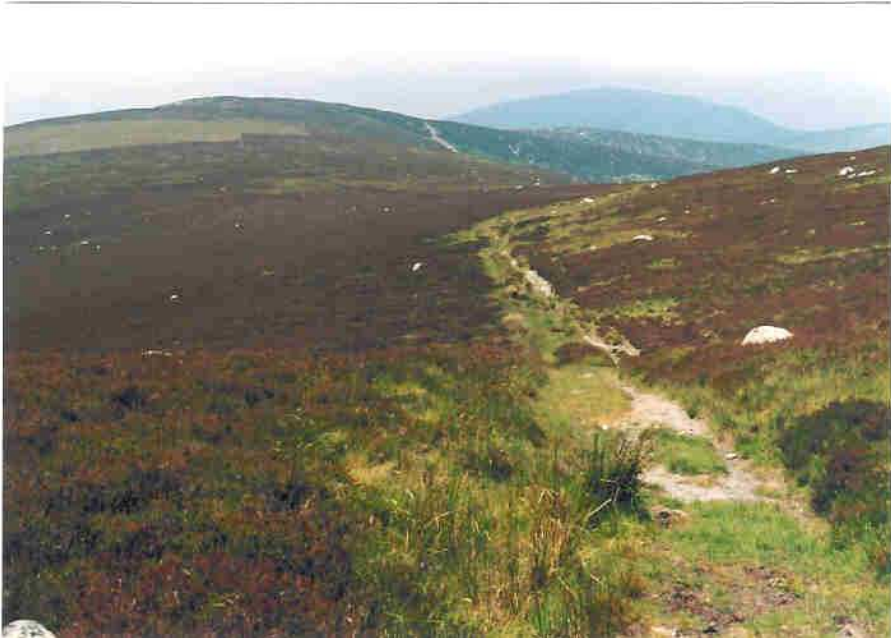
<p>pic18 shows path ahead to Brockagh summit 557m (top left of pic, <u>not</u> the obvious scar, middle top)</p>

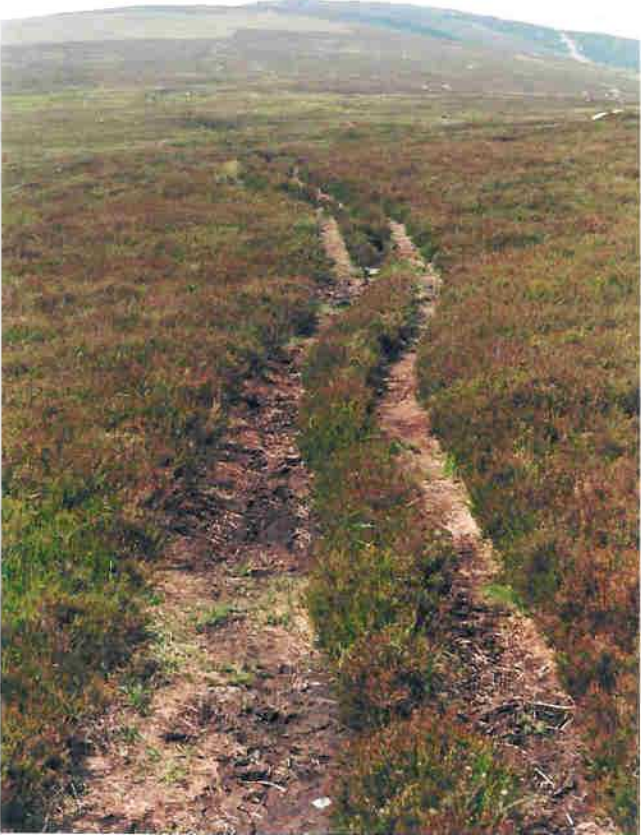
8	40m on	path widening as it goes downslope
9	250m on	path needs to be defined; peat depth < 5cms
10	122 ₄₄ 984 ₉₈	junction; track goes on and down slope to the right; narrower path to Brockagh goes left
11	30m on	<p><u>pic19</u> shows braiding x 3; peat depth = 30-35cms; Brockagh summit in the background</p>

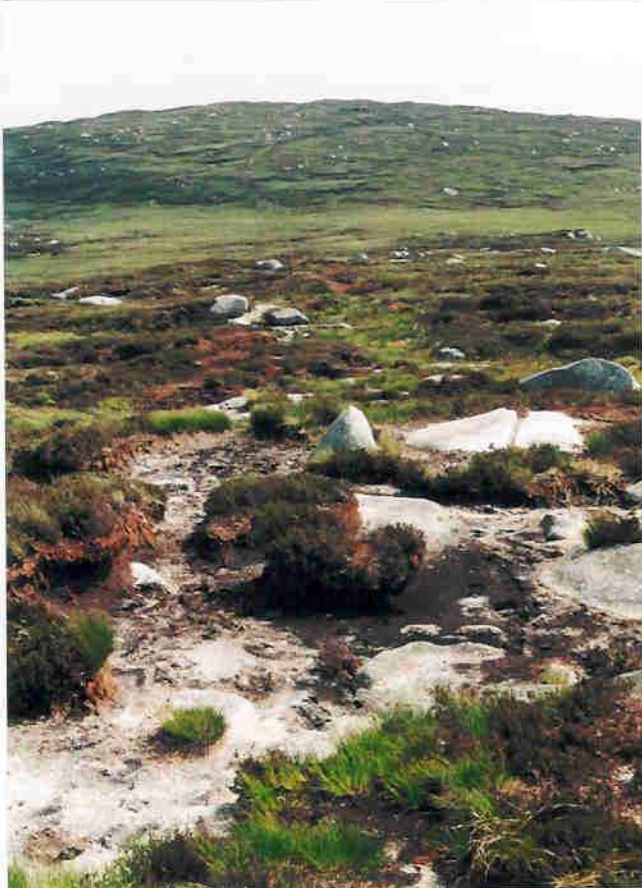
<p><u>pic20</u> looking back at Brockagh summit; shows broken nature of path; marshy area visible in mid-ground</p>
27	105 ₅₅ 998 ₁₃	large boulder (3m high); path now improves going down slope
28	150m on	wet areas; path divides up for the next 100m as it reaches the flat
29	T 103 ₀₄ 999 ₄₈	lowest point; wet area; path ill-defined; large boulder (No. 27 above) can be seen behind, on the horizon

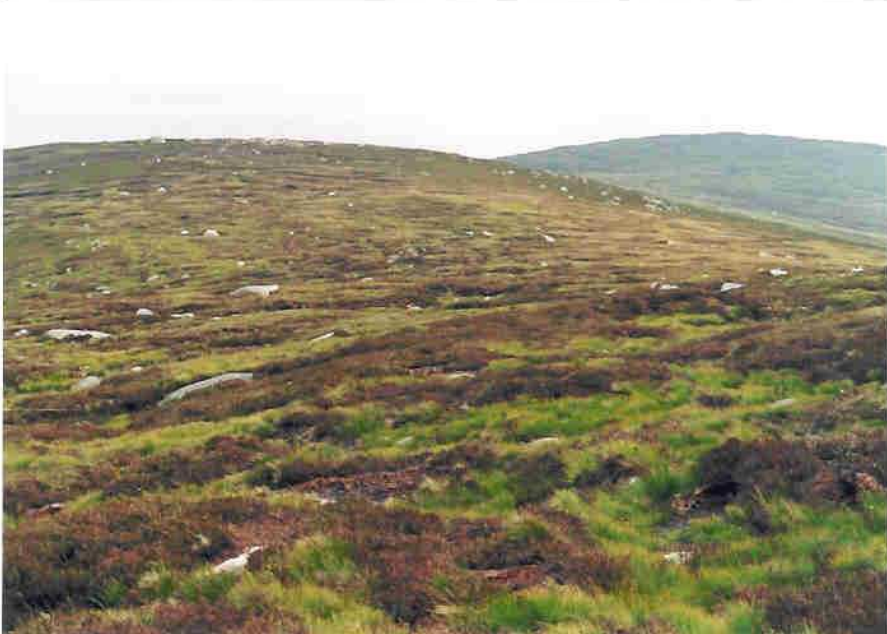
30	<p>○ 101₂₇ 000₇₉</p>	<p>pic21 looking back shows broken nature of the path: large boulder on top-left, Brockagh summit top-right</p> <hr/>
