Wicklow Mountains Path Survey

| Camaderry | |
| Surveyed by: | John Monaghan, 27 / 6 / 02 |

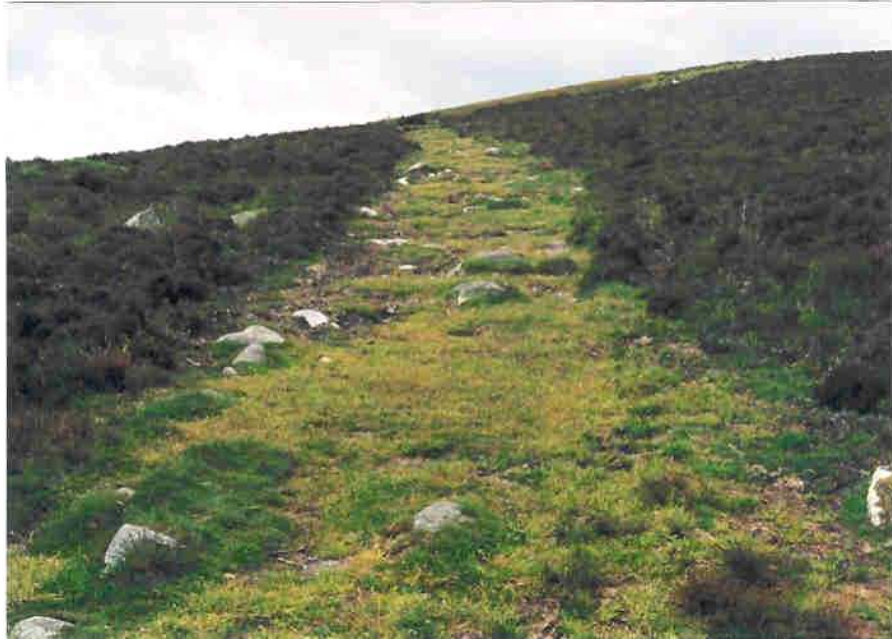
| 6 | 10715 97100 | <p data-bbox="431 453 724 485">heather on either side</p> <p data-bbox="431 1125 971 1157"><u>pic22</u> looking up shows path 3 - 5m wide</p> |
