Wicklow Mountains Path Survey

Corriebracks Church Mtn.	
Start to Finish:	S 96709 99743 to S 95266 99906
Altitude (lowest – highest):	350m – 544m
Weather:	Sunny, dry, strong wind
Access:	Snugborough Bridge, Donard
Surveyed by:	John Monaghan 19 / 6 / 03

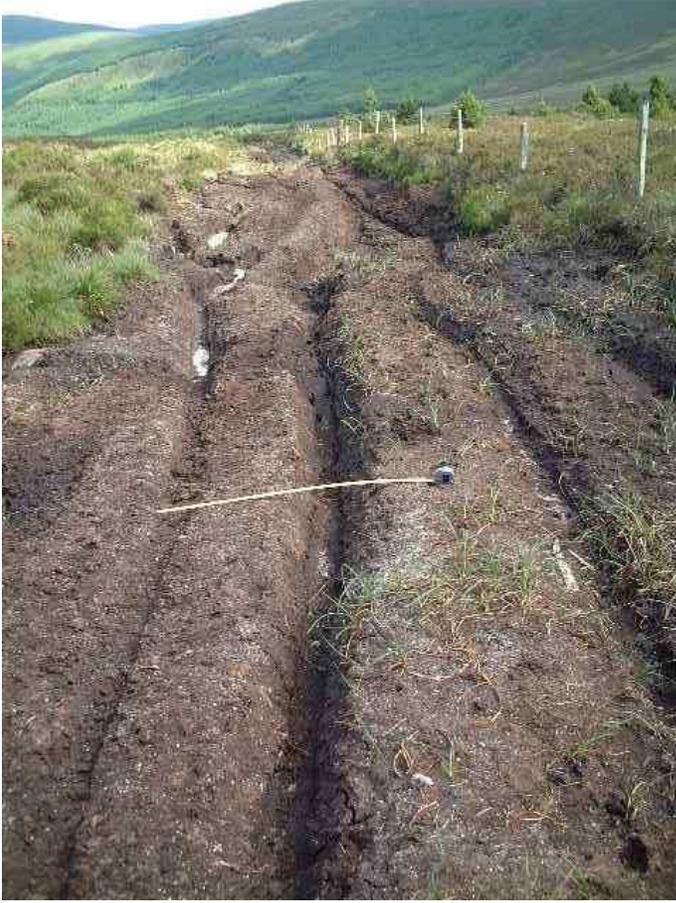
No	Pos Irish Grid S & N	Comments / Photographs
1	96709 99743	<p>Start south of Corriebracks top where the path turns left at the NE corner of the forest; Note: the forest boundary here, as shown on the OS Sheet 56 map, seems to be incorrect (see sketch below)</p> <p>there are two or more indistinct single file paths on broken peat / heather from the indistinct top of Corriebracks to this point</p>
2	same	<p>deep (30cm) tyre tracks in the soft peat; path width = 4m; new parallel paths forming up on the heather to the right</p>
3	96624 99833	<p>pic 24v looking back towards the corner shows deep ruts in the peat; tape = 1m</p>

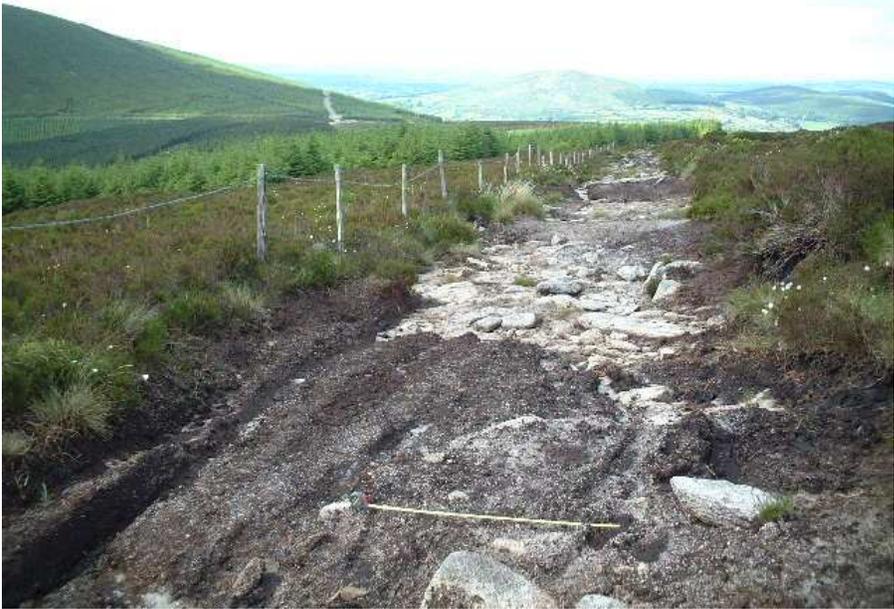
5		track turns right, still at the edge of the forest; surface again more peaty; no forest to the right as shown on the map and noted at the start
6	96280 00190	<p>pic25 looking ahead towards Slieve Corragh, east slopes of Church Mtn at top left, shows the mixed nature of the track, peat and stone; tape = 1m; path width = 4m</p>

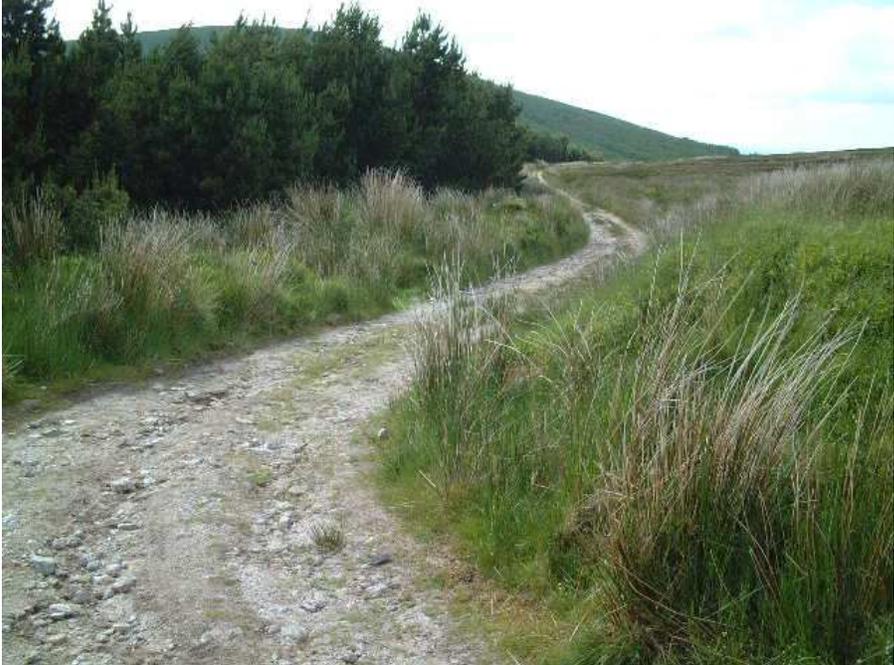
8	96044 00633	<p>track turns right; pic26 at the turn, looking ahead; width = 2m; Church Mtn ahead through the trees</p>

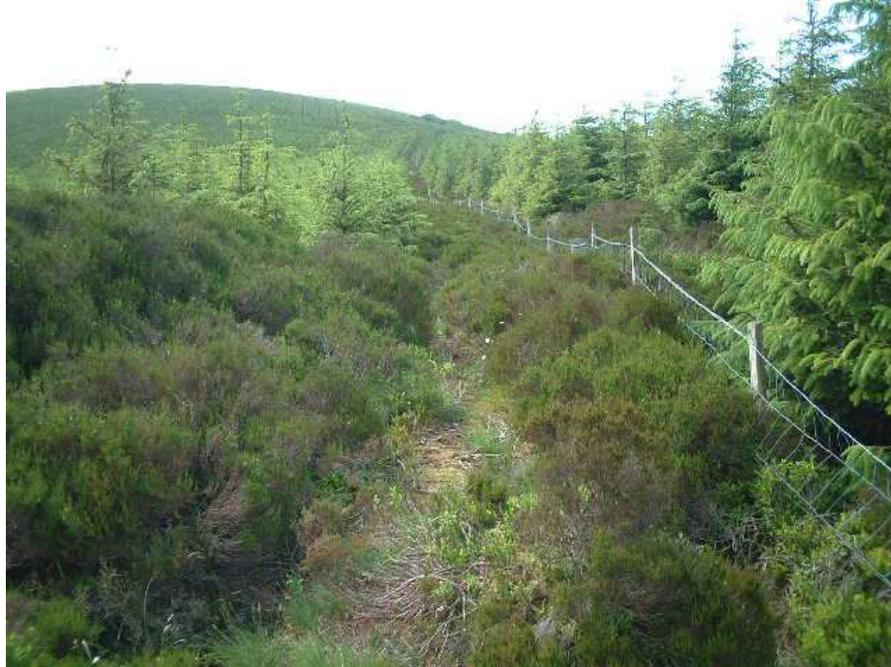
pic27 shows the narrow single file path, indistinct at first, going up the slope of Church Mtn, forest on either side

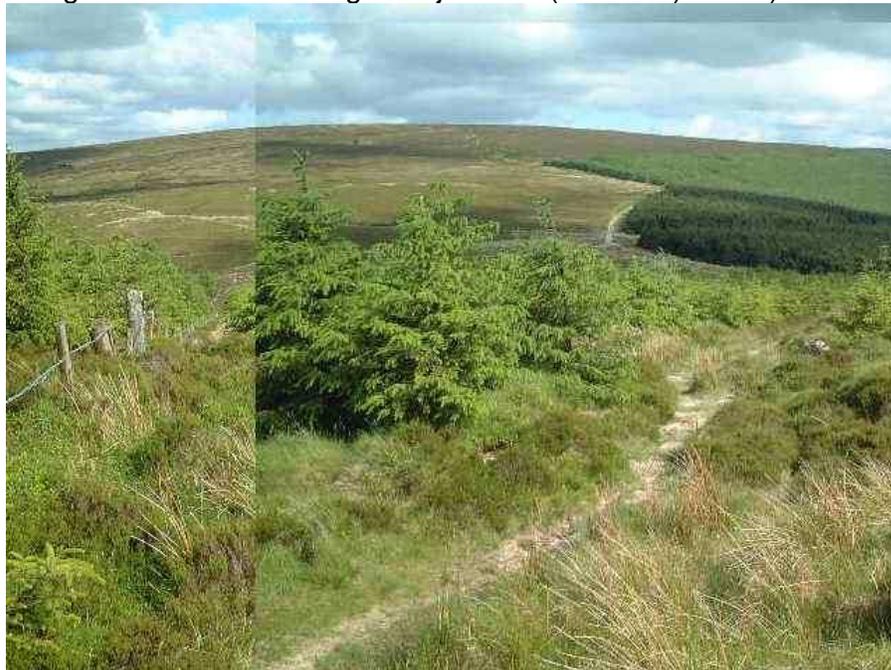
pic28/30, a composite of two photos, looking back down shows the indistinct path on the left coming up by the fence, the more mature path joining it, the route earlier along by the forest edge, the junction (no.9) at the bottom left corner of the dark area of forest, Corriebracks in the background

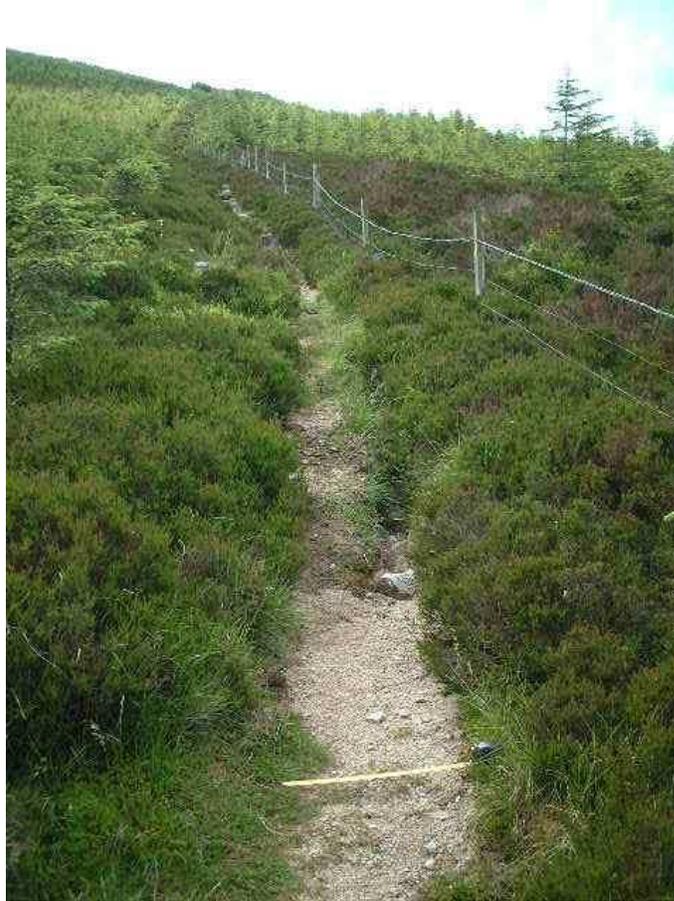
pic32v looking ahead, tape = 0.5m, shows the first of the deep gullies (30 cms deep) on this path, just beyond the tape

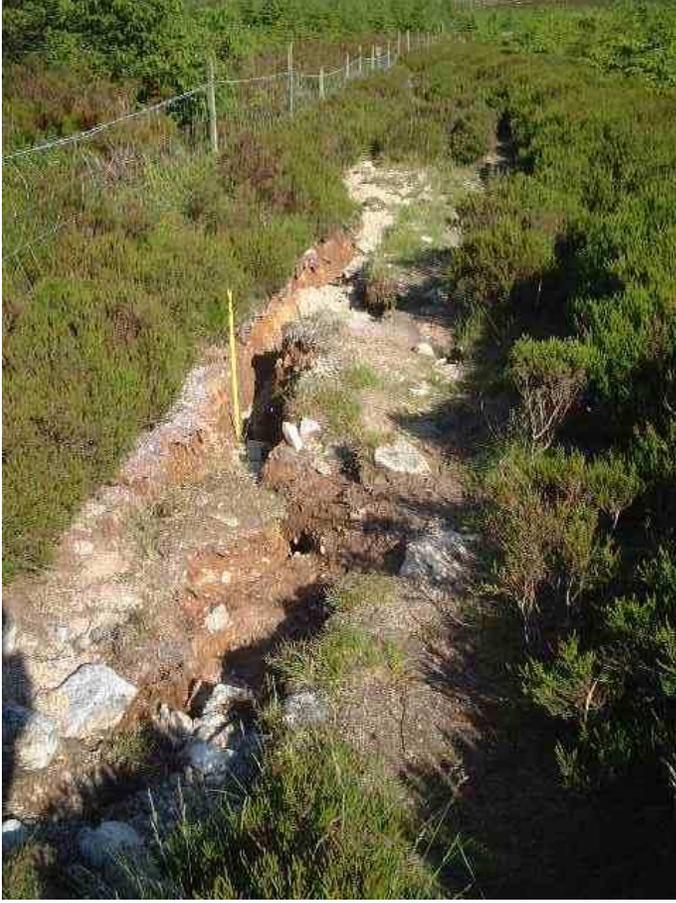
14		<p>pic33v looking back down shows deep gully going down to 80 cms; tape = 1m</p>

15	95272 01266	<p>still dramatic water erosion, gullied and the soil being washed down in wet weather; path on bare stone; at this point the path is widening to the left on the heather as walkers try to avoid the deep holes</p>

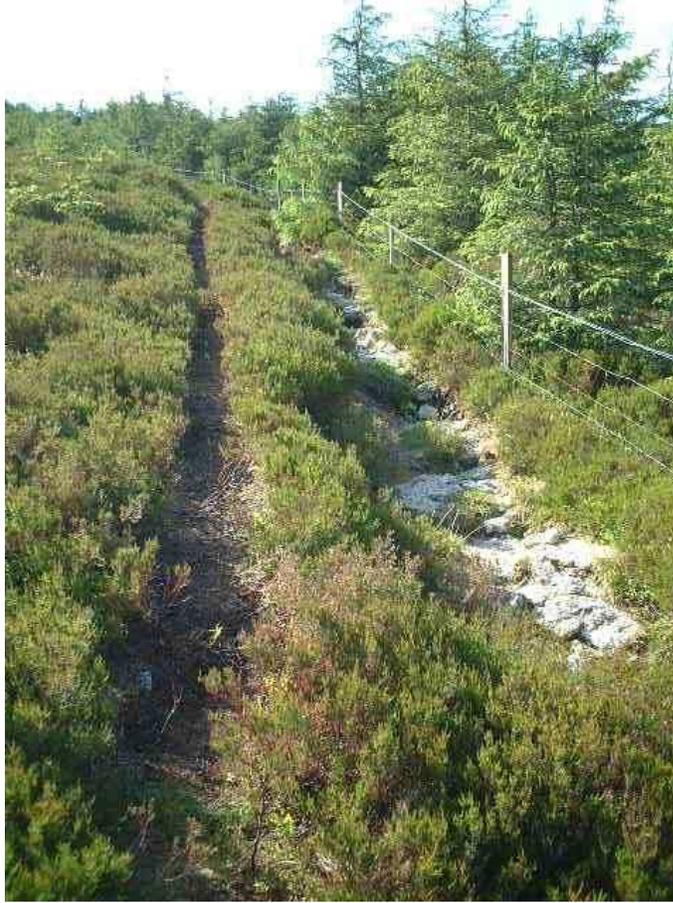
pic34v shows a parallel single file path through the heather above
and to the left of the eroded path

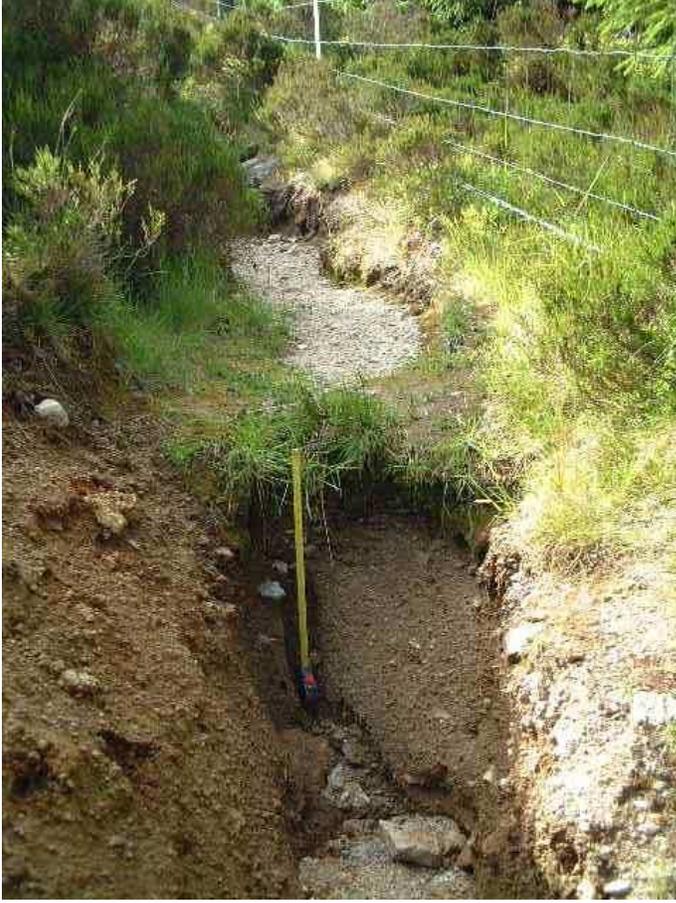
17	10m up	<p>pic35v shows a closeup of one of these holes not clearly visible in the previous photo; tape = 0.5m</p>

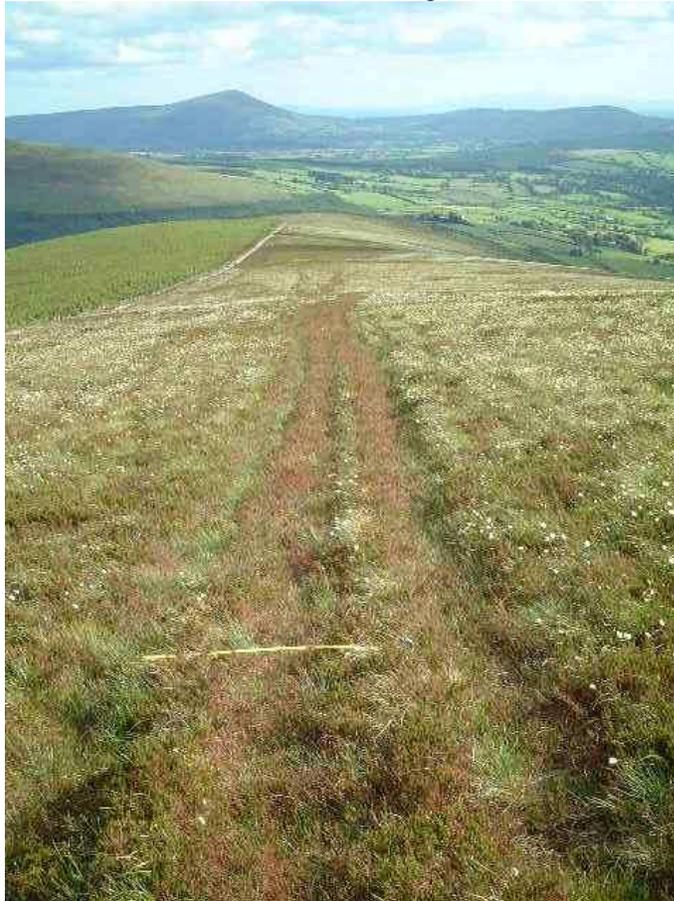
going S from the summit, pic38v shows the lightly eroded path on the south slope; the heather cover still partially intact; tape = 1m; the track which I left earlier below on the left bordering the young forest; below that again the western spur of Lobawn in mid distance; Keadeen in the background

this path can be seen to split further down as walkers make their way over to join the forest track

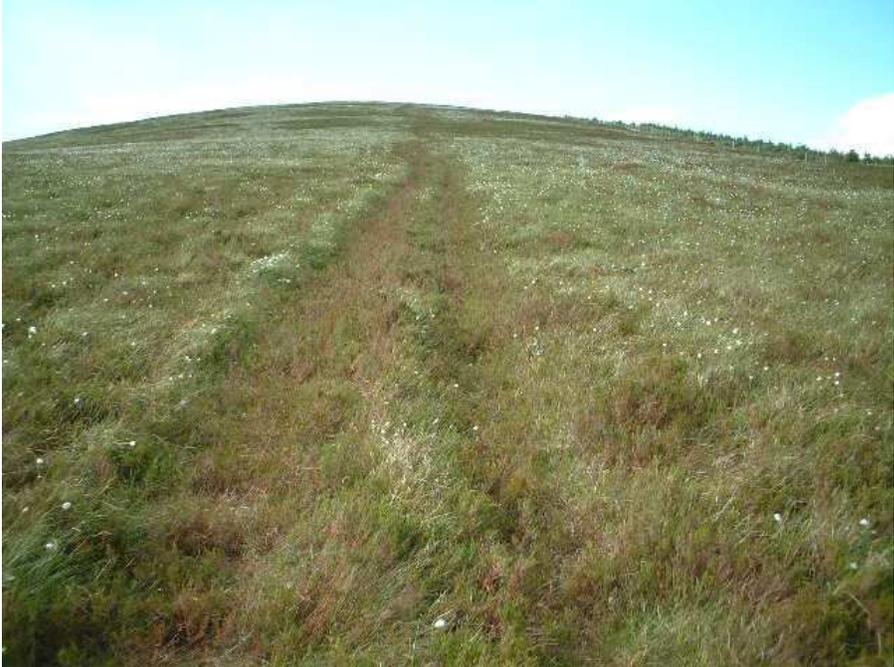
23	94918 00853	<p>pic39 looking back up shows the path to the summit; path width = 1.5m; forest can be seen top right</p>

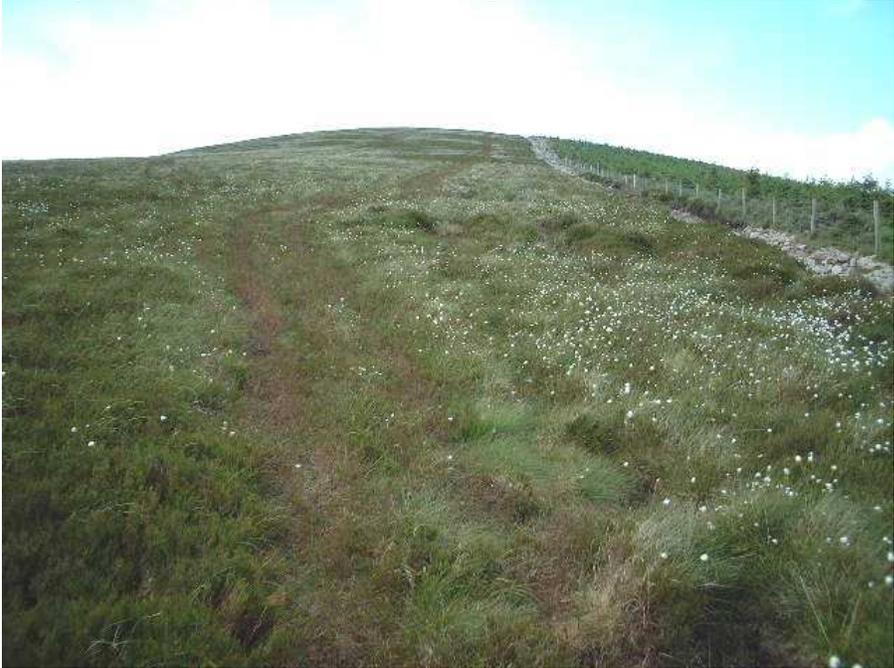
<p>pic40a looking back up, shows this extra path (2) winding its way uphill; the forest track is on the right; the surveyed path can barely be seen off to the left, nearer the summit</p>

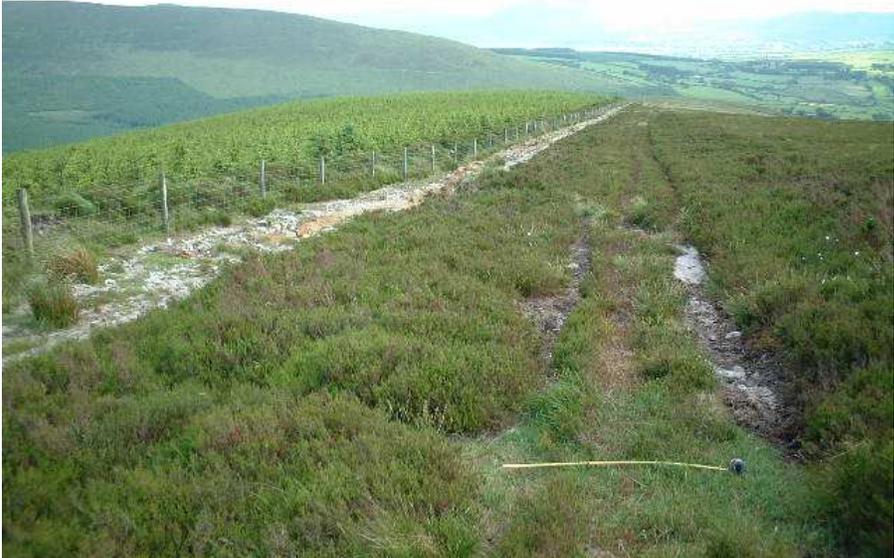
<p data-bbox="431 779 1284 877">pic41 looking downslope, shows this extra path getting more eroded as it runs parallel to, and about 5m from, the forest track; tape = 1m; the western spur of Lobawn in the background</p>
26	same	<p data-bbox="431 951 1279 1050">across from where pic41 was taken, the forest track has a 60cm deep gully running down it for a short distance, caused by water erosion</p>
27	94924 00167	<p data-bbox="431 1125 1279 1224">SE corner of the forest; Imaal Walkers 2001 wooden seat donated by Coillte at the corner; a very faint path runs straight ahead S for a few metres but peters out</p>
28		<p data-bbox="431 1299 1279 1398">the track follows the forest boundary and runs SE (mag. bearing 140°) by the edge of the forest, steepening as it approaches another forest track below running N-S</p>

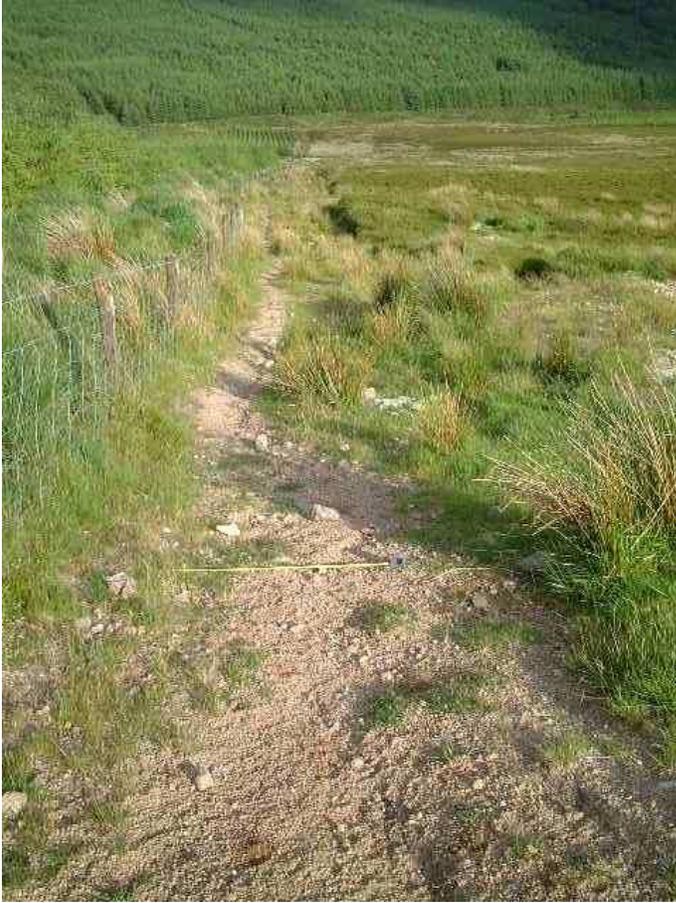
29	95056 00066	<p>water damage, gullies crossing the track</p>

<p>pic42v looking down the slope, shows the path, the surface a mix of grass / stone; path width goes out to 3m in places, narrowing further down; tape = 1m (water damage not shown)</p>
30	95266 99906	<p>track reaches forestry track running N – S at a gate with a stile at the side and a "Unauthorised Entry Prohibited" sign</p>
31		<p>END</p>
