## Wicklow Mountains Path Survey

<b>Cullentragh - Mullacor</b>	
Start to Finish:	T 11270 93624 to T 09270 93930
Altitude (lowest – highest):	495m – 657m
Weather:	Sunny
Access:	Shay Elliot memorial, Laragh-Drumgoff road
Surveyed by:	John Monaghan 25 / 6 / 03

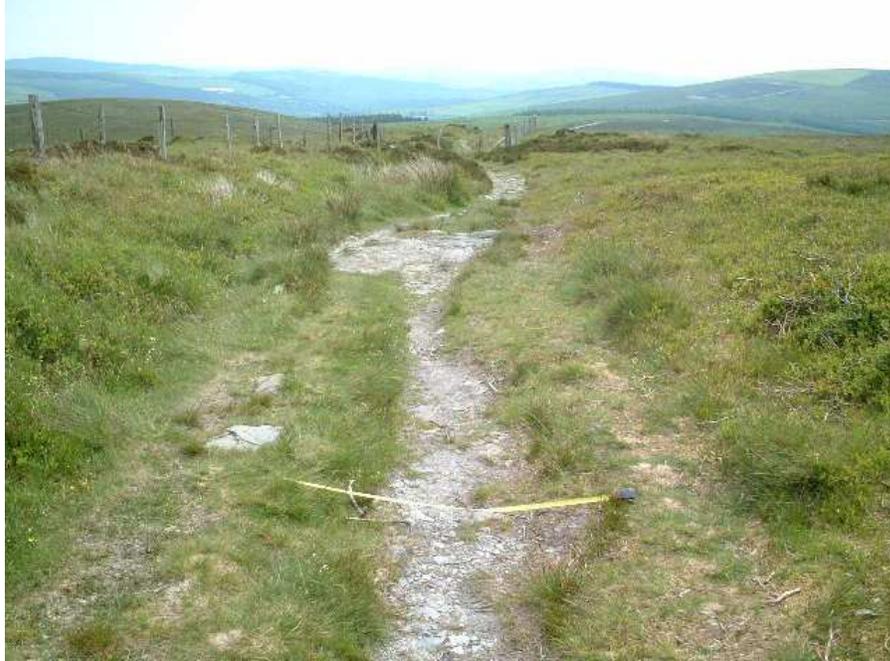
2

pic8 looking back at the fence / stile; the path a stony section in the middle, widening on either side; tape = 1m

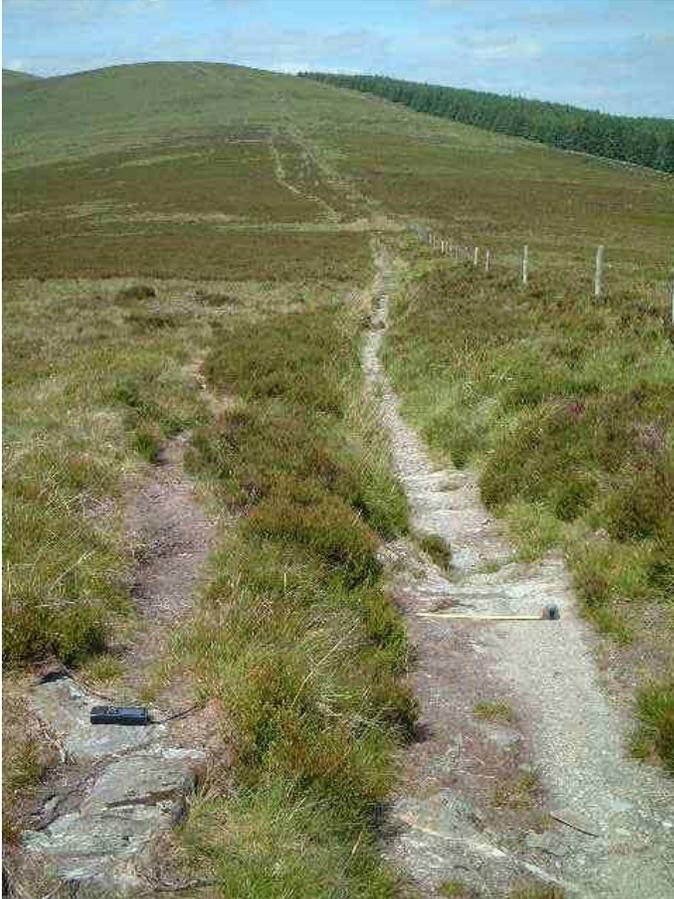
3	11136 93690	<p>pic9v looking ahead down the gentle slope shows the path braiding, a new path through the heather on the left (see gps); main path along by the fence (tape = 0.5m); Mullacor "East Top" in the background</p>

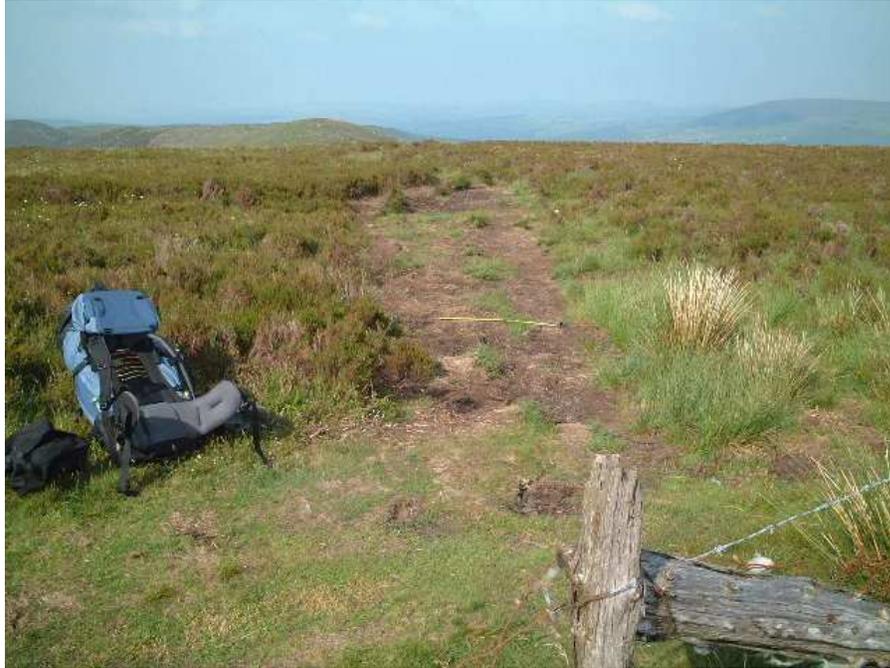
8

a path from Derrybawn ridge, 3m wide on peat, joins the route here (ref. No. 34, Derrybawn survey), linking up with a path running parallel to the present path on the other (N) side of the fence

pic43 looking NE shows the path from Derrybawn coming towards camera to join the path on the N side of the fence; tape = 1m; Derrybawn (Pt.488m) in the background

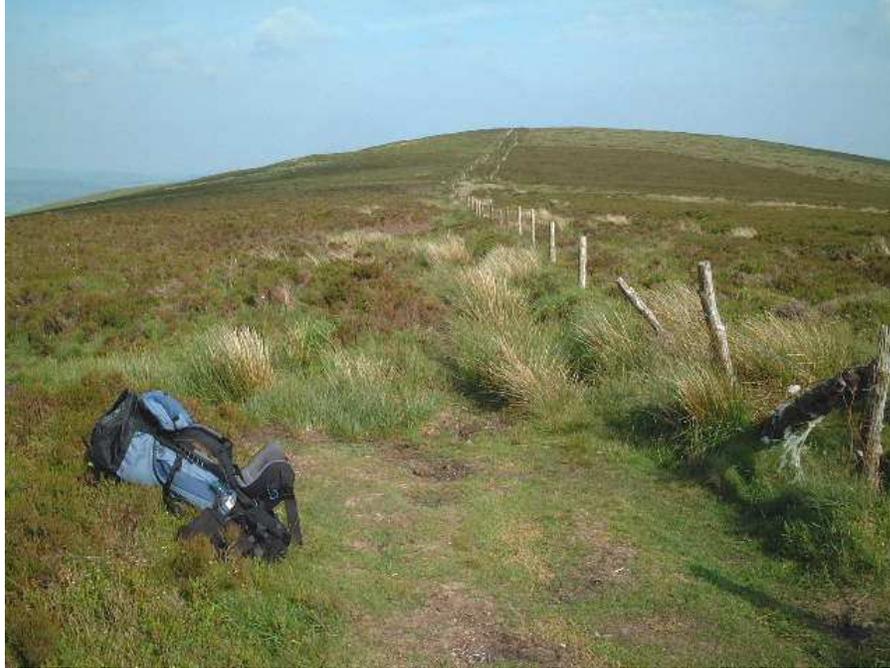
9

pic44 at the junction, looking E, shows the route back towards Cullentragh; the path from Derrybawn comes in from the left in the foreground; the path along by the N of the fence is not well defined; the main path is on the right (S) of the fence and can be seen running parallel to the fence near the top of the slope in the distance

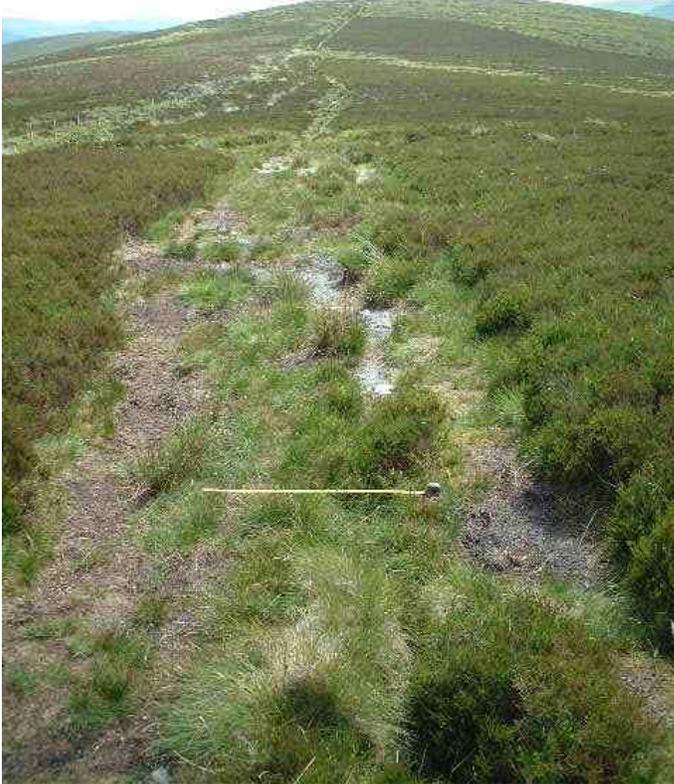
10	10770 93850	<p>pic10v looking back shows a long distance view of the main path back to Cullentragh top; tape = 1m; the path widens briefly to 2m here; the path from Derrybawn (not visible) joins the route on the left of the photograph</p>

<p>note: there is another less defined path on the N side of the fence running parallel to this one; it is barely visible on the left of the photo</p>
11	10700 93882	path width = 4m; grass / peat surface; heather on either side
12		the next section of path c. 3m wide; the edges not well defined; on grass / peat

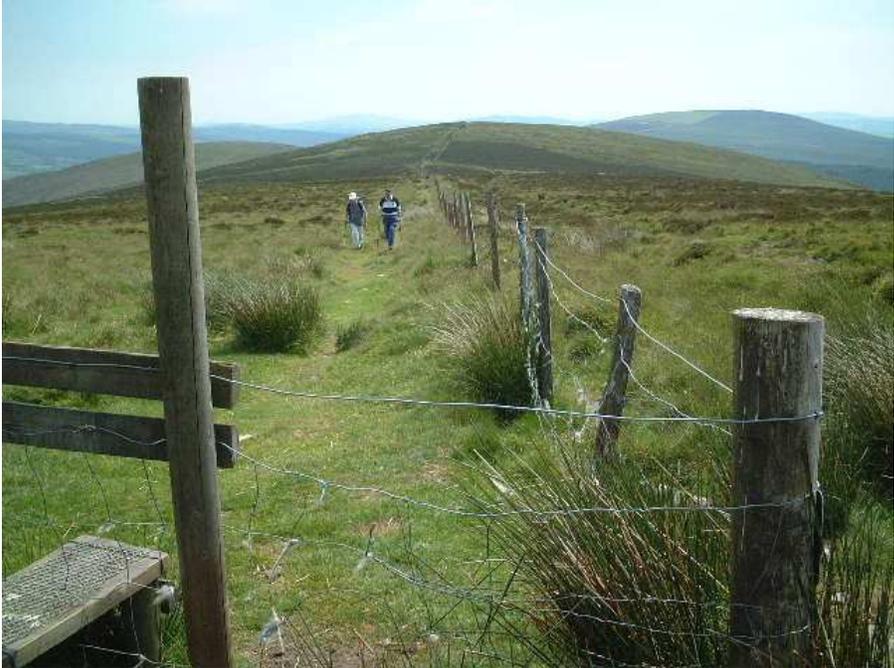
<p>pic11 looking back along the route shows the path on the N side of the fence about 2m wide on grass, two walkers approaching; the stile bottom left; the main path from Cullentragh is on the right of the fence</p> <p>the ground around the stile is eroded</p>
<p>14</p>	<p>same</p>	<p>pic12 looking ahead up the slope, the path on grass / mineral soil; tape = 1m; the two walkers heading for Mullacor "East Top"</p>

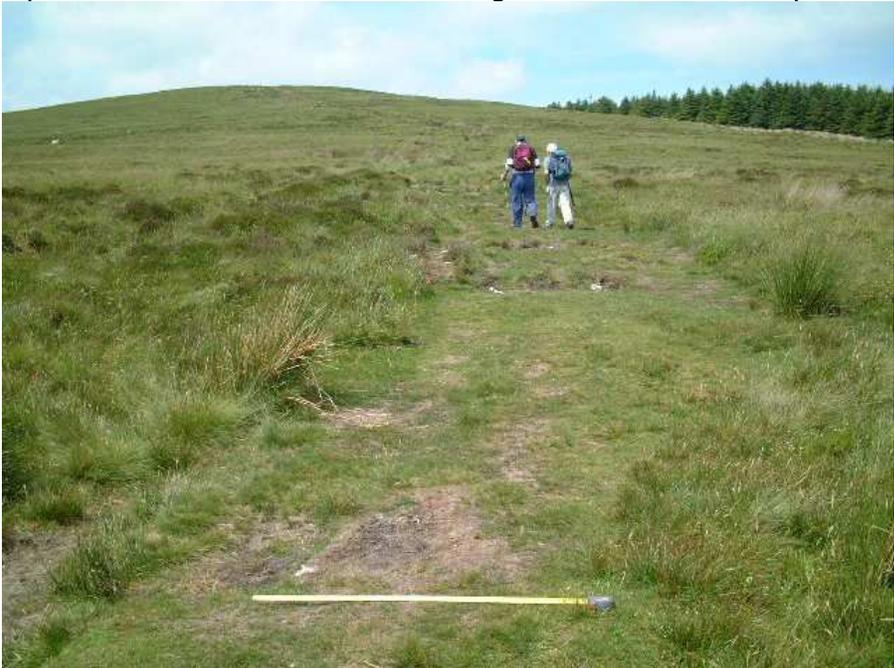
15		the 50m section of path up from the fence / stile is avg 4m wide, then narrows to 2m on a stable surface of grass / mineral soil / peat
16	1048 9398	pigeon holing where the grass slope steepens; above this the grass cover is getting bare
17	further up	another step on steep slope pocked and holed
18	10445 94000	<p>6m wide area of stone / bare rock; the path splitting; grass / heather mounds in the middle</p>

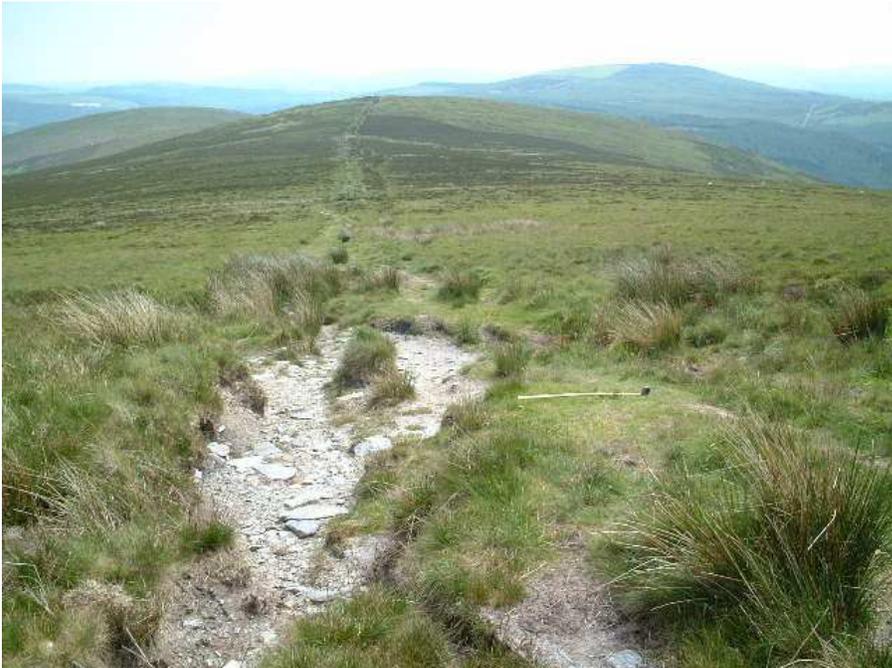
<p>pic14 looking back at this area; tape = 1m; note the path going around the stone area on the right; fence / stile below in the distance</p>
19	50m up	the slope steepens; wet area; path briefly goes out to 9m

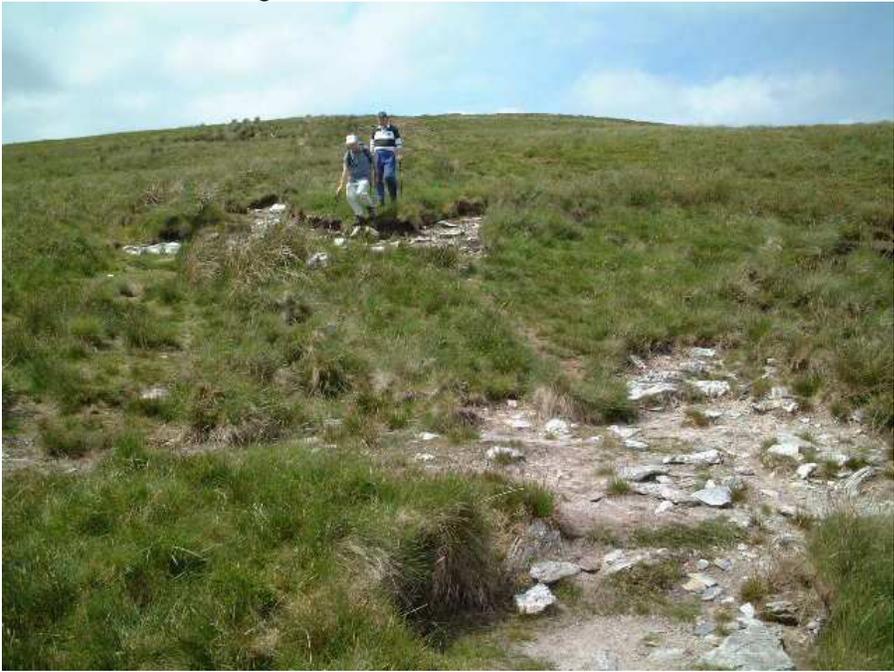
20	10354 94004	<p>pic16 looking up the slope; the path edges not defined here; rather a mix of stony sections and damaged heather / peat going out to 9m, extending for c. 30m</p>

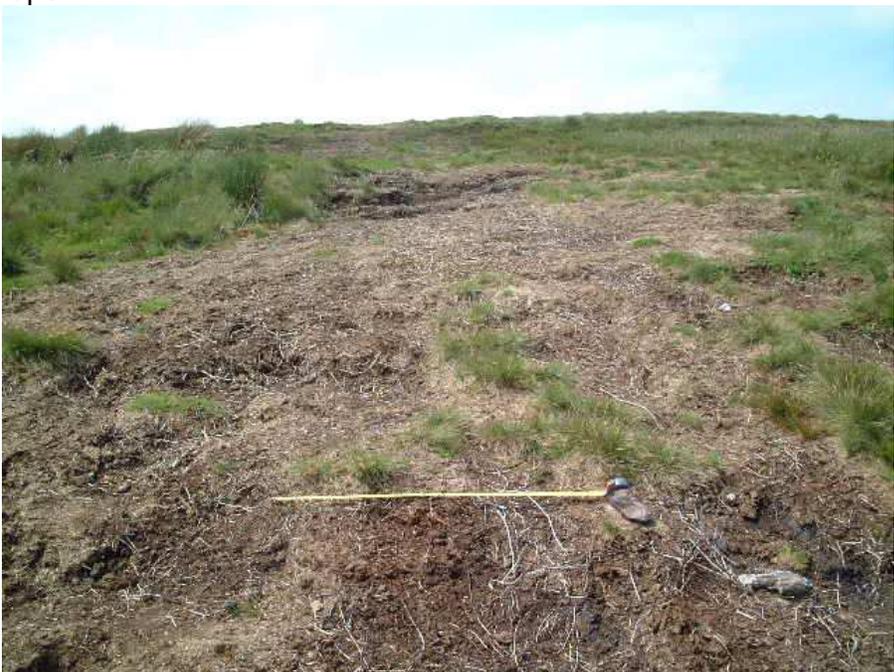
21		<p>the path splits briefly as it exits the stony section</p>
22	10277 94010	<p>the path surface changes to peat / damaged heather roots; path width = 10m; pic17 looking ahead up the slope shows this; tape = 1m</p>

<p>in the middle of the photo the path narrows to c. 6m but potential for widening here as the grade steepens</p>

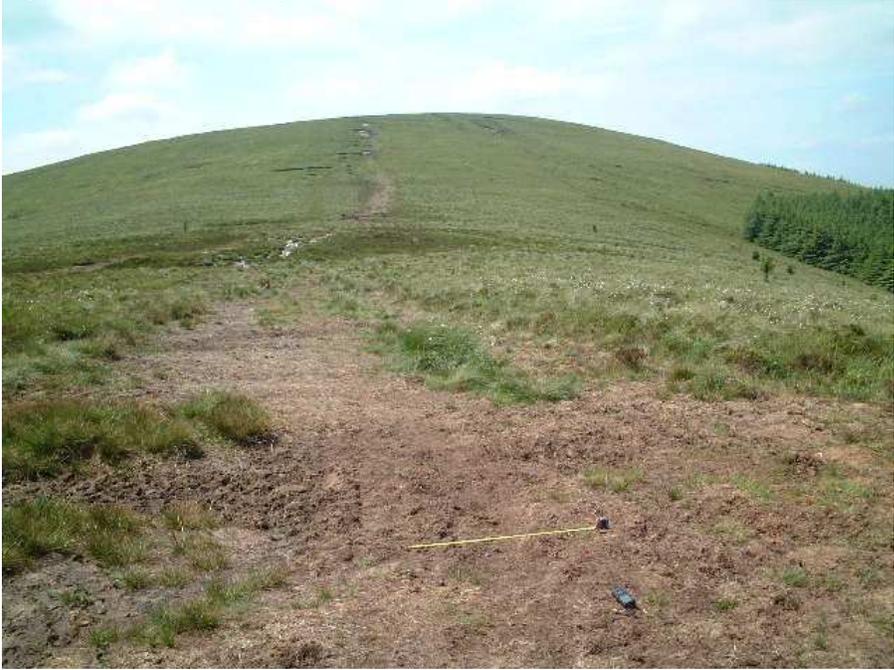
23	10167 94009	Mullacor "East Top"; a small heap of stones mark the top; this flat area is eroded, going out to 10m
24		<p>the section of path for the next 80m is initially 3m wide but going out to 20m, edges not well defined, to.....</p> <p>..... a flat, wet "roundabout" area with two bog pools, sphagnum moss surface</p>
25	10017 93986	as it begins to go downslope, the path splits up; there are cross paths between the two; the total path width / damage = 18m on a soft peat / grass surface
26	09940 93986	<p>pic18 shows the path ahead to Mullacor; gps bottom right; tape = 1m; path beyond the tape narrows to 6m</p>

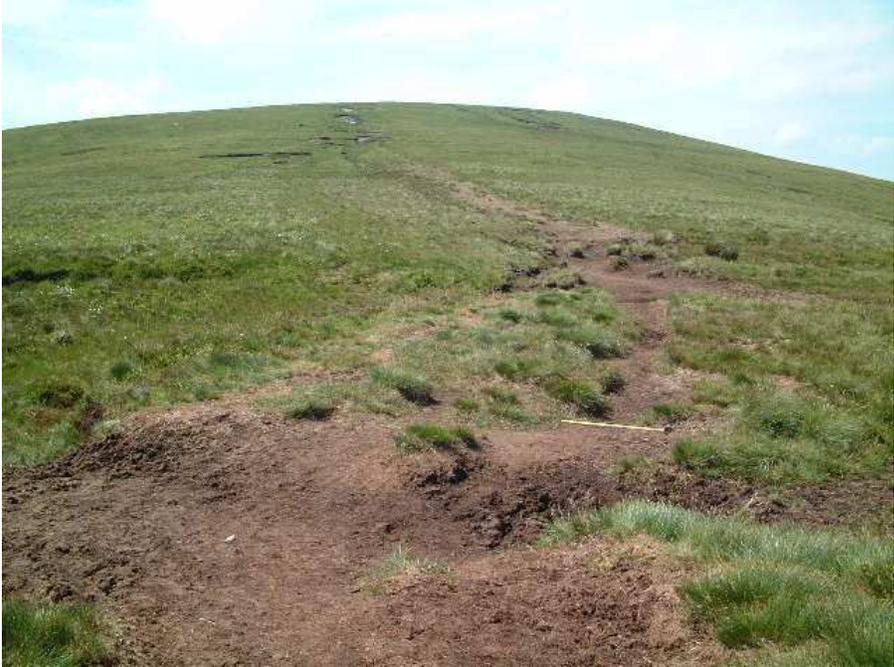
<p>29</p>	<p>09784 93952</p>	<p>pic19, taken opposite a 3m high conifer on the left, looking ahead up the slope; tape = 1m; wet area 30m ahead</p>

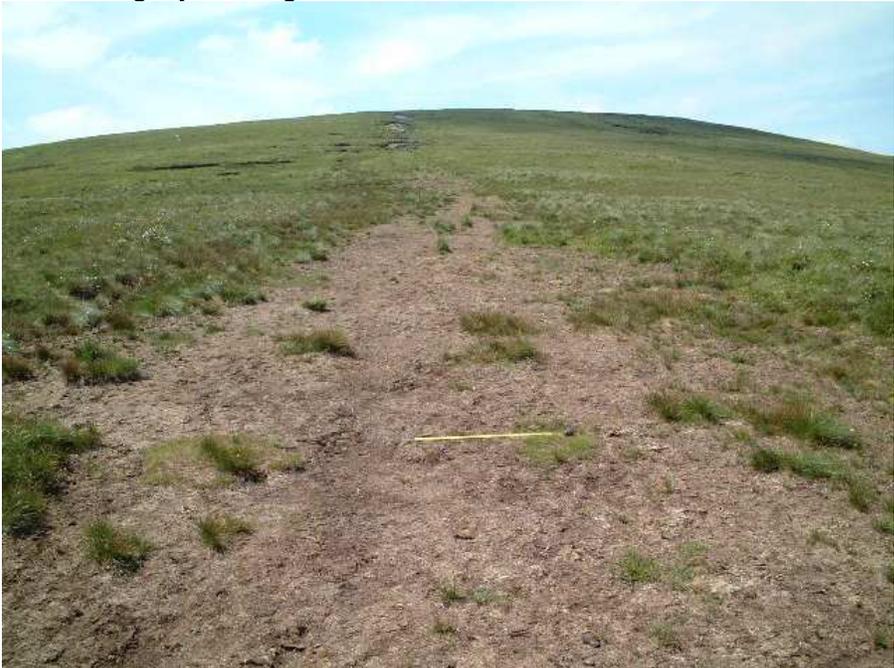
<p>30</p>	<p>09717 93957</p>	<p>pic20 looking ahead; path width = 9m; tape = 1m; water channel / gully coming down on the left hand side</p>

32	09560 93932	<p>eroded peat section (as seen at the top of pic20 above); the ground broken / eroded over a wide area</p>

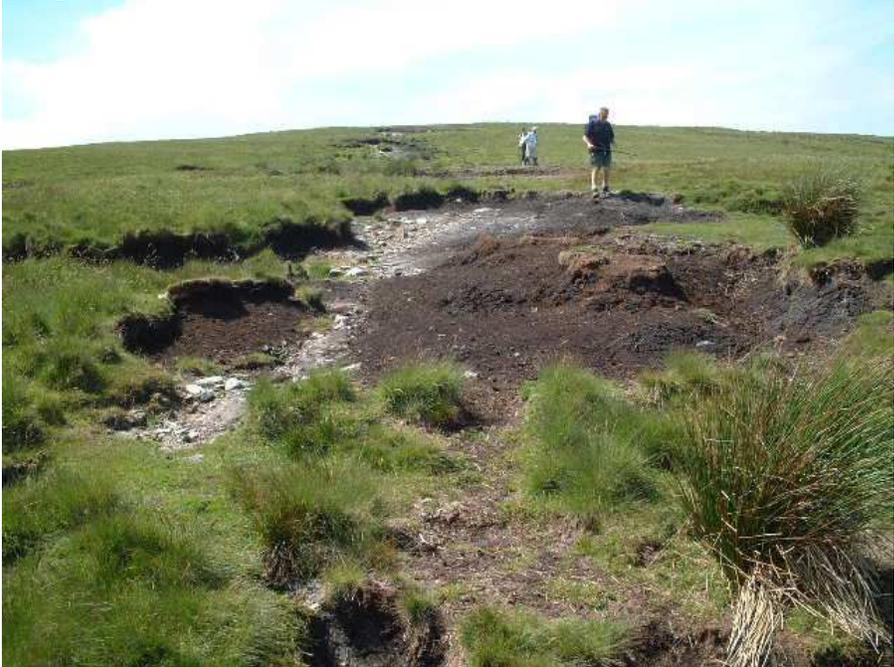
<p>pic21 looking up shows natural erosion (peat / turf banks) compounded by trampling; walkers descending</p>
33	same	<p>pic22 looking back down from the same position shows the predominantly grass section below</p>

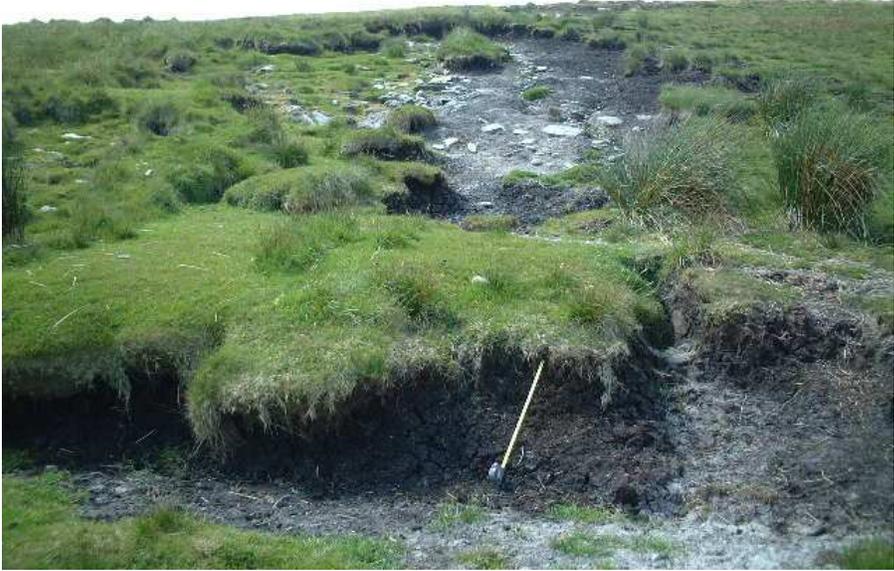
34	80m up	<p>pic23 looking up shows peat bank; tape = 0.5m; above it a badly eroded section with more damage on grass out to the left; the peat bank up further is 70 cms high</p>
