Wicklow Mountains Path Survey

Lough Bray	
Start to Finish:	O 140 ₀₀ 175 ₅₀ to O 141 ₇₀ 163 ₇₀
Altitude (lowest – highest):	370m – 555m
Weather:	Sunny, after rainy June.
Access:	Rathfarnham – Sally Gap road at start and finish given above
Surveyed by:	John Monaghan, 20 / 6 / 02

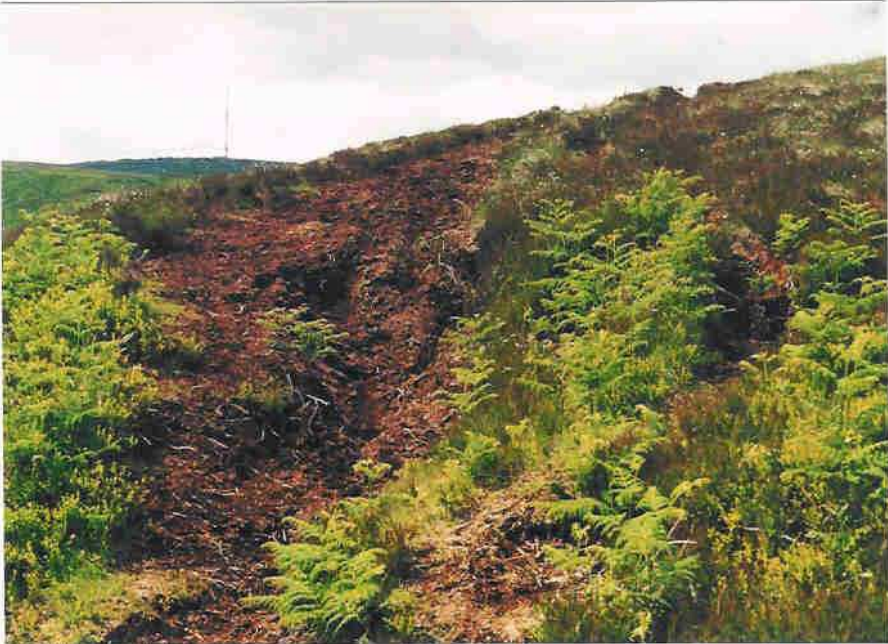
<p><u>pic37</u> looking W up the slope shows braiding, new path on the right; Kippure mast in background</p>
5	100m on up	path has divided into 4 "single file" paths
6	13425 16877	path divides; main path to the left (nearest lake)
7		path on edge of steep heather slope; single file width

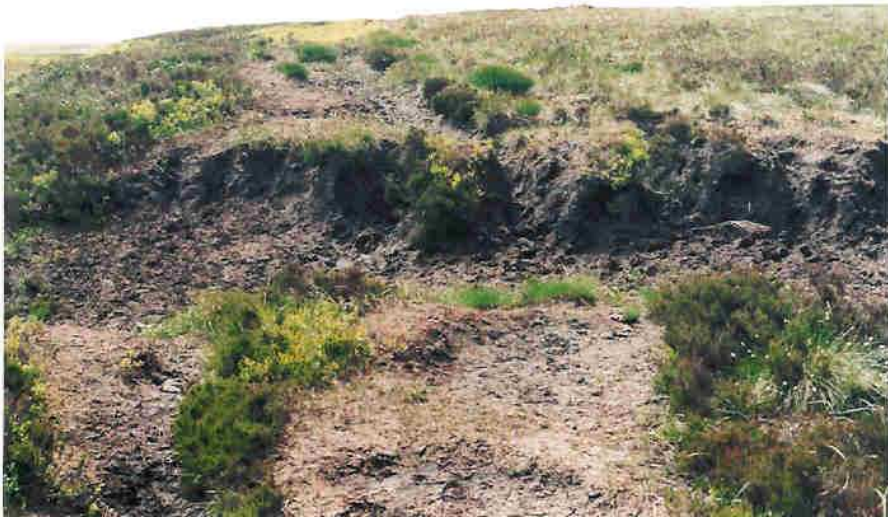
11	same

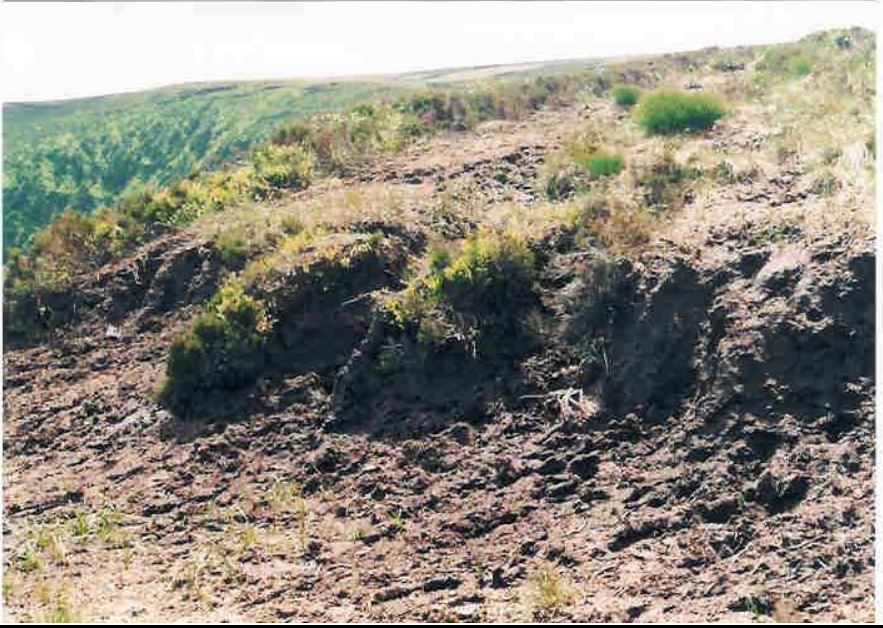
<p data-bbox="430 779 802 810"><u>pic1</u> shows same, closer up</p>
12	further on	<p data-bbox="430 877 1211 947"><u>pic2</u> shows a general view of the path ahead; tyre tracks in foreground; a need to drain water off the path here</p>

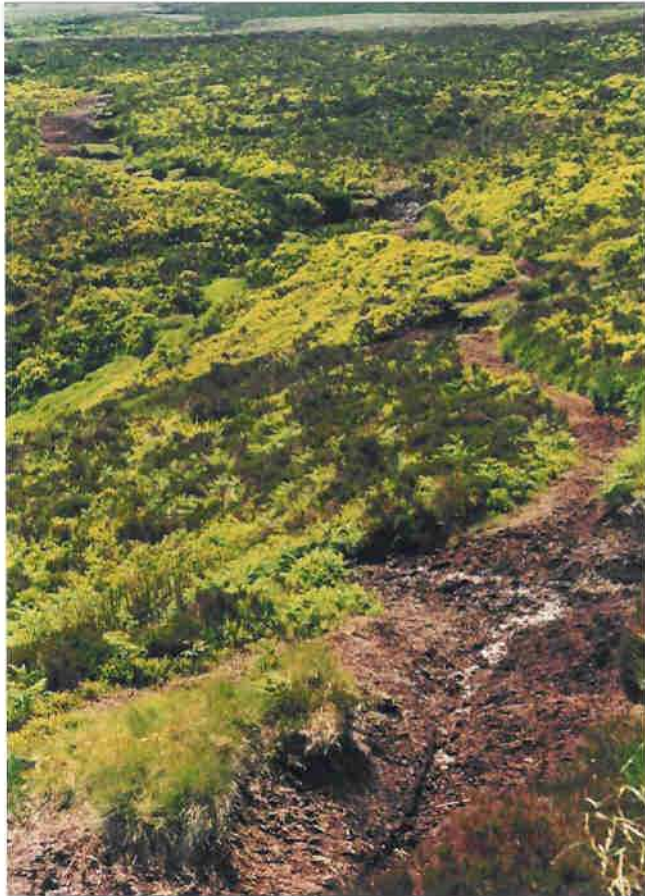
13	12958 16510	wet grassy patch and braiding followed by eroded bank
14	50m on	more braiding, just before small stream enters large gully down to the lake below; the path divides here, soon 30m apart; I followed the higher one
15	12895 16393	<p>pic3 shows path ahead ascending steep slope</p>

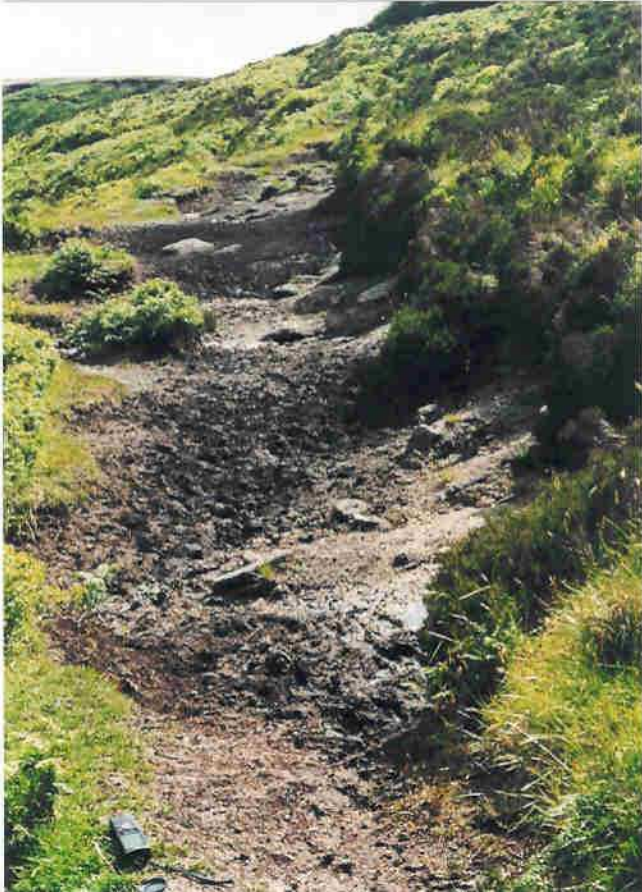
19	13129 16045	path divides again; the lower, narrower one contouring to the left; I followed the wider one going uphill to the right, crossing a small stream over a badly eroded bank
20	13274 15951	more eroding banks crossing small stream; large loose stones available here to make a bridge across to stabilise the peat banks
21	13500 15950	Eagle's Nest – numerous paths here; eroded and badly torn up area generally
22	same	path divides up again going SW from the Eagle's Nest; I took the lower path on the left
23	200m on	wet area; 3 parallel paths now close together
24	13370 15770	<p>pic6 shows wet area ; (GPS in foreground); path width \leq 4m</p>

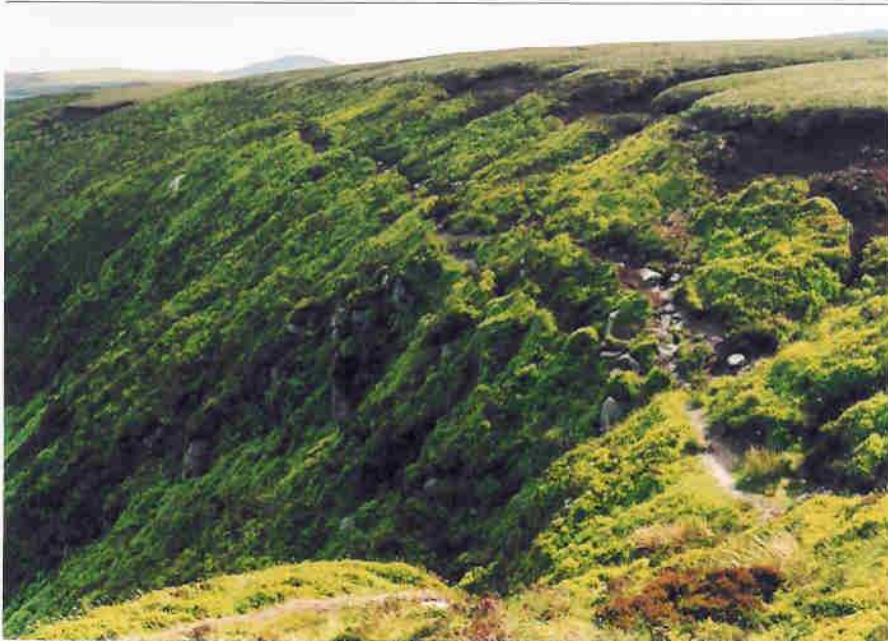
25		there are large stones further on which could be used for surfacing work
26		path in good condition, less than 1m wide at two large 2m boulders
27	13266 15536	<p data-bbox="435 390 1122 426"><u>pic7</u> shows path ahead after crossing the large gully</p>

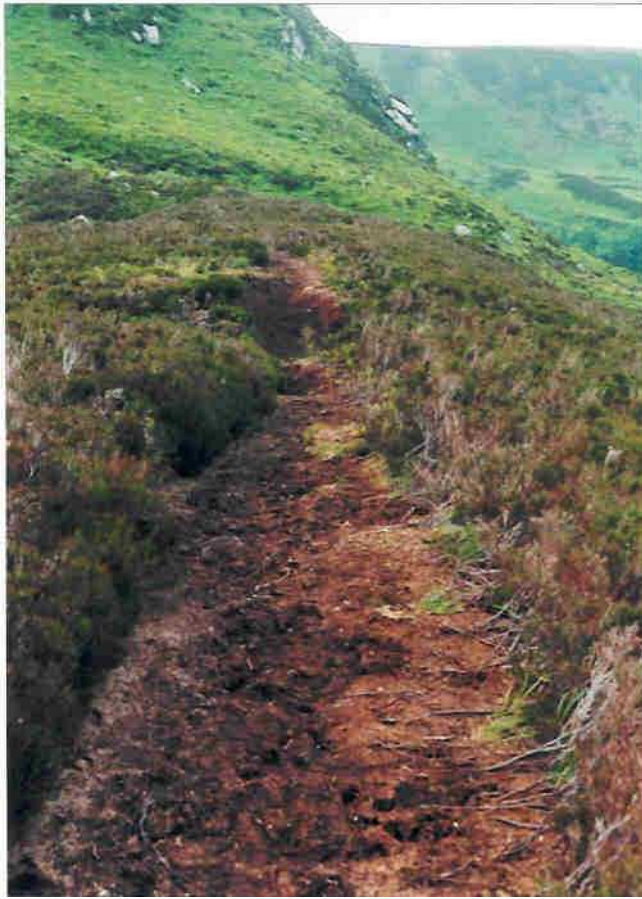
pic14 shows the worst part of the path along the crest of the moraine; 1- 2m wide; the Eagle's Nest is out of sight straight ahead and above; a narrow minor path goes down left to the lake shore from here; I turned right here, away from the lake

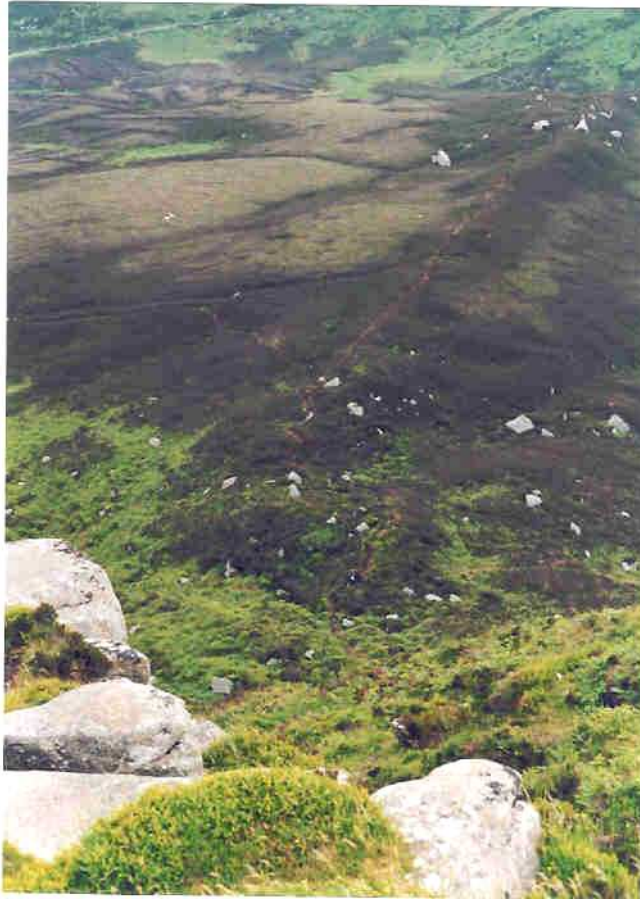
pic5 looking down from the Eagle's Nest, shows an overall view of the path along the top of the moraine, and the turn down towards the finish of the route
