## Wicklow Mountains Path Survey

<b>Paddock Hill - Scarr</b>	
Start to Finish:	T 146 <sup>85</sup> 981 <sup>74</sup> to O 132 <sup>65</sup> 018 <sup>36</sup>
Altitude (lowest – highest):	350m – 641m
Weather:	Sunny, fresh breeze, after rainy June.
Access:	Forest entrance on Glenmacnass road at T 141 975 or laneway at T 158 996 on Oldbridge-Laragh road.
Surveyed by:	John Monaghan, 17 / 6 / 02.

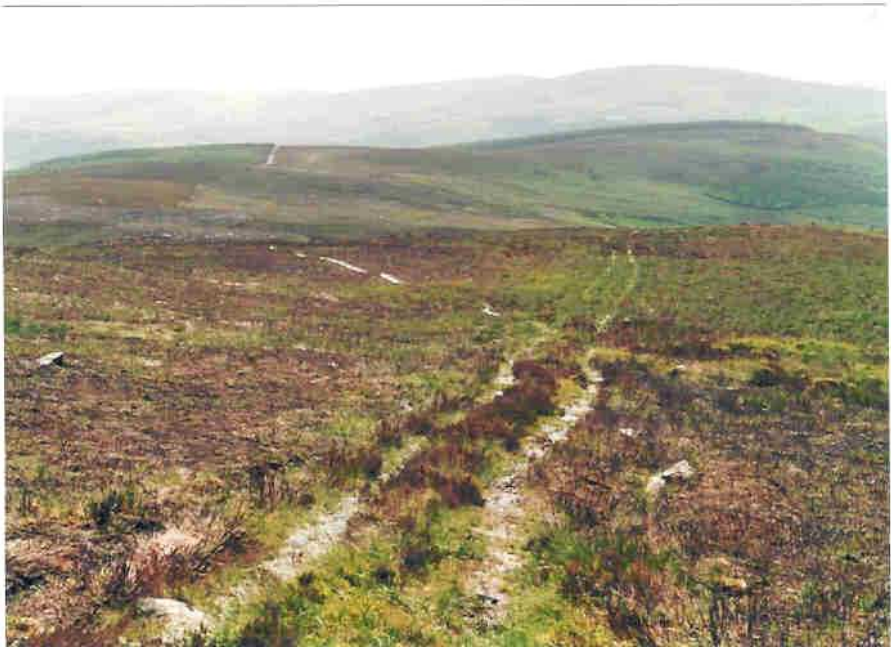
11	O 135 <sub>50</sub> 002 <sub>21</sub>	path now wide, braided, like "car tracks"; two other single file paths parallel to it 30m and 60m to the right (NE)
12	O 134 <sub>52</sub> 004 <sub>06</sub>

<p data-bbox="435 968 1154 1066"><u>pic14</u> looking back down (SE) at the "car tracks"; one of the single file paths joins up with our main path; forest edge (pts 5 and 6) can be seen at top left.</p>
13	O 133 <sub>09</sub> 006 <sub>15</sub>	wet area for the following 50m
14	O 132 <sub>10</sub> 008 <sub>01</sub>	path a watercourse here

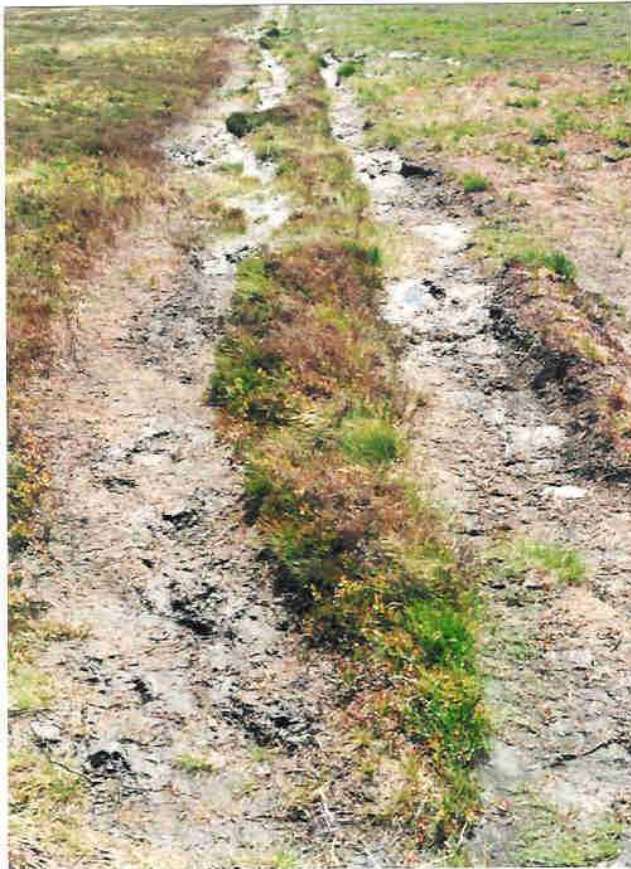
O  
132<sub>04</sub>  
009<sub>30</sub>

pic21 looking S, shows braiding and surface water on the path

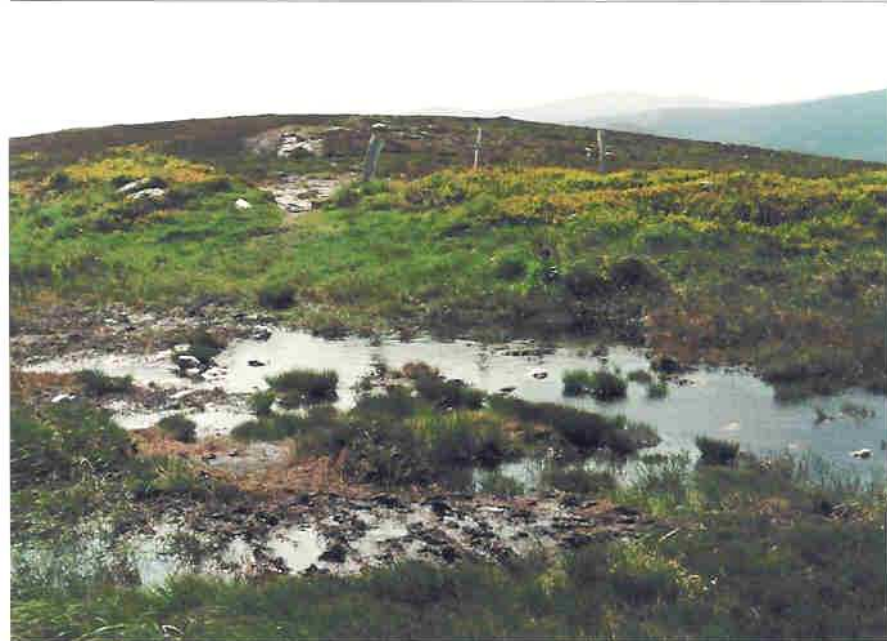
O  
132<sub>09</sub>  
011<sub>08</sub>

the path 100m both sides of the fence in bad condition, wet and mushy

pic15 at fence, looking back (S)

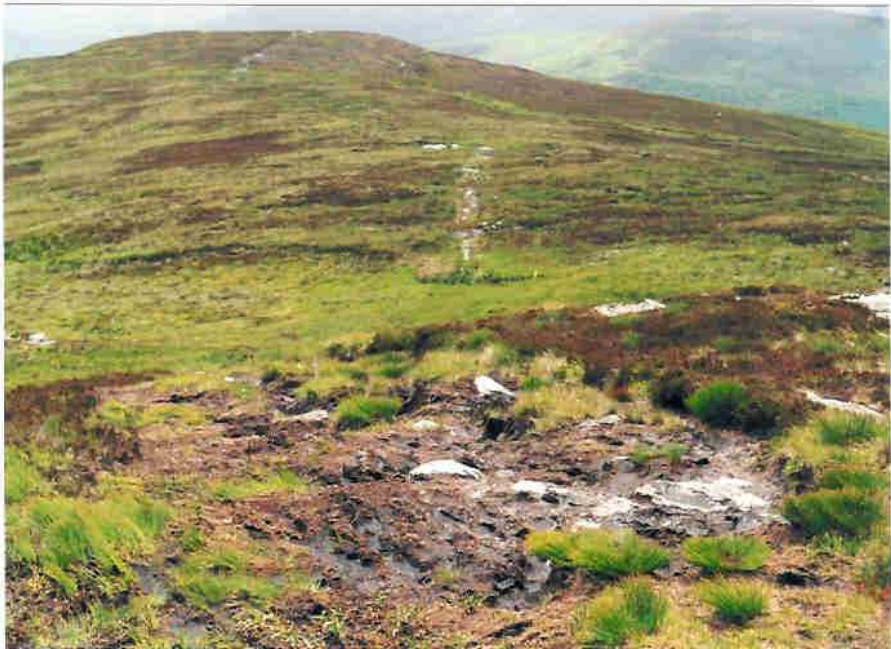
<p data-bbox="435 961 1321 997"><u>pic20</u> on the ridge south of Scarr summit, looking back down (S)</p>
19	O 131 <sub>93</sub> 015 <sub>03</sub>	wet area on the "saddle" between the summits; no materials, stone or timber visible for restoration work along the path
20	O 133 017	wet area on the saddle between Scarr's two main summits
21	O 132 <sub>65</sub> 018 <sub>36</sub>	Scarr summit
		END
